CHAPTER 1

Compositional analysis of municipal solid waste (MSW) of Vadodara city and study of the fungal diversity

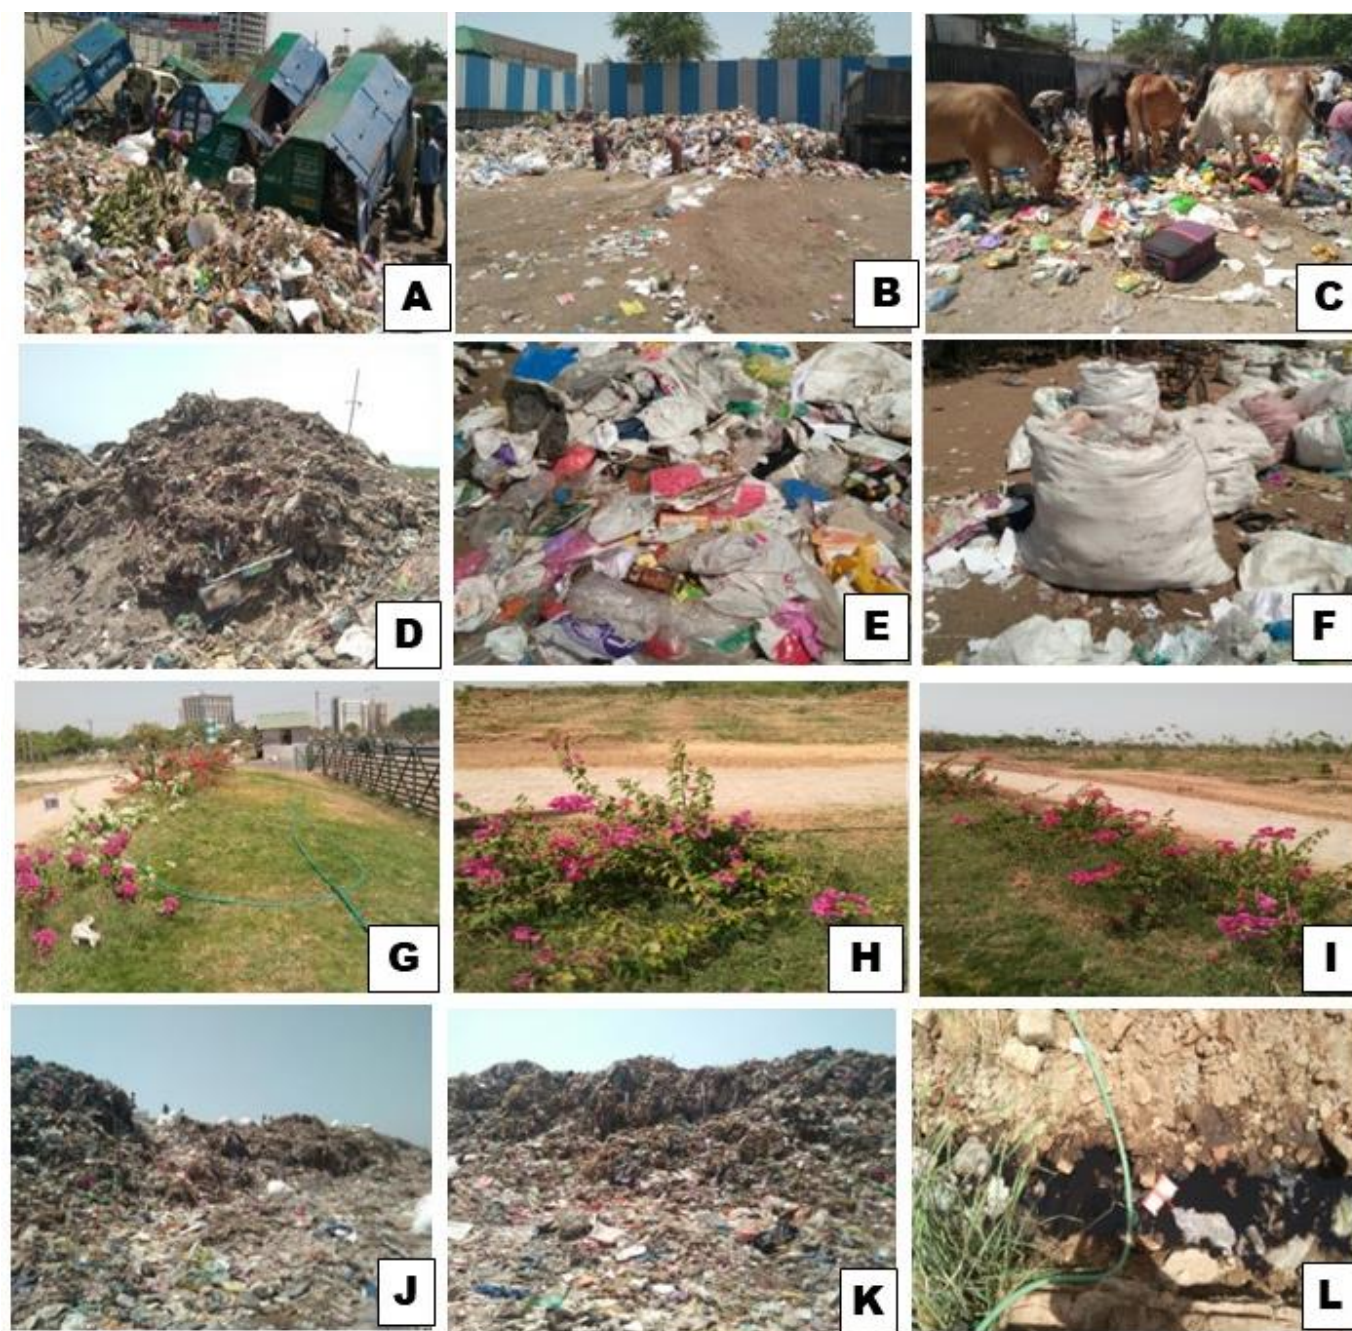
Figure.3. A-F: Temporary Dumping sites of Vadodara City

A-Karelibaug area; **B-** Waghodia area; **C-** Atladara area; **D-** Atladara dumpsite with ten-year old waste; **E & F-** Segregation of recyclable waste; **G-I-** Old dumpsite converted into garden at Atladara area; **J-L-** Jambuva Landfill area (**J & K-** Waste Disposal; **L-** Leachate separation)

Near VUDA Bhawan (Karelibaug) dumping site segregation of recyclable waste is being conducted by rag-pickers. Further this segregated recyclable waste such as glass bulbs & bottles, milk bags, used plastic bottles (Cosmetics & Soap) (Figure.3.) are being supplied to scrap dealers. At Atladara and

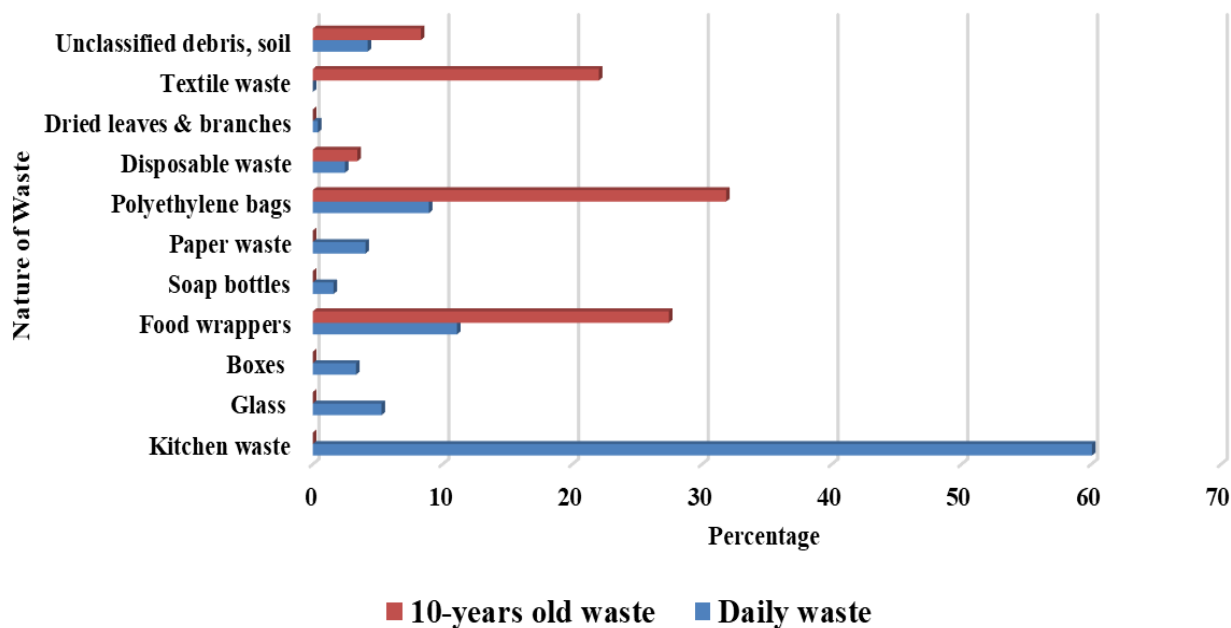
Figure.4. Comparison of daily waste (temporary dumping sites) and 10-years old waste samples (Atladara dumping sites)

Atladara dumping site has two locations in which one is for daily waste and other location has more than ten years old waste. Comparison of daily waste samples and ten-year old sample indicates that kitchen waste, paper & box waste get degraded by microorganisms in a period of few months as displayed in Table.2 & Figure.4. The analysis of waste samples collected over a ten-year period reveals important insights into the recycling patterns and composition of waste in Vadodara. The finding that soap bottles, milk packaging bags, and glass wastes are being recycled is encouraging, as it demonstrates a level of environmental consciousness and responsible waste management.

In this analysis it reveals that approximately 25% of plastic waste is present in municipal solid waste. Among these all-plastic waste products highest percentage was of polyethylene bags. (Table.3 & Figure.4.) No significant difference was noted in the composition of waste when two different seasonal waste sample were compared. As per review article given by Sharholly *et al.*, 2008 MSW
